Slope Stability Assessment along Qalachwalan-Suraqalat Main Road, Sulaimani, NE-Iraq

Ghafor A. Hamasur , Nzho M. Qadir

Department of Geology, College of Science, University of Sulaimani, Sulaimani , Iraq

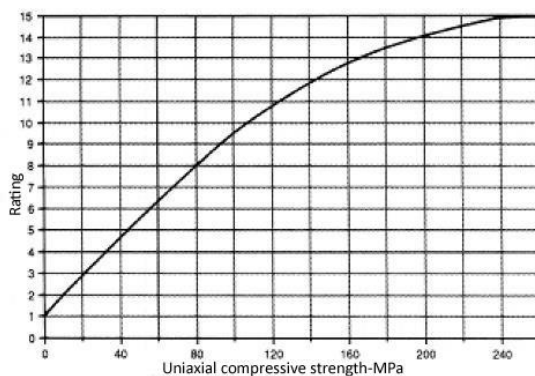
Fig. 2: Variation of rating for the uniaxial compressive strength [19]

RMR system is based on field and laboratory study, which includes uniaxial compressive strength (UCS) of the intact rock, rock quality designation (RQD), discontinuity spacing, discontinuity condition and groundwater condition, Table (1). The rating of these five parameters can be obtained from Table (1) and Figures (2, 3 & 4), then the ratings are added to give a value of RMRb (basic RMR).

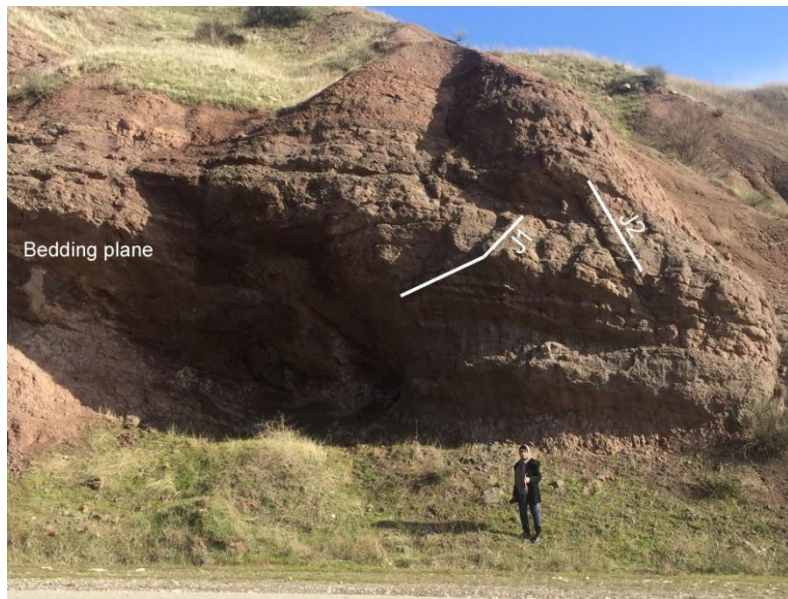
Fig. 6: General view for slope at station no.1 with marked discontinuity sets

3) Potential for flexural toppling about (So) at stations 1, 2, 3, 4, 6, 7, 8 & 10 as shown in Figures 5c, 6, 7c, 8, 9c, 10, 11c, 12, 15c, 16, 17c, 18, 19c, 20, 23c & 24.

4) Potential for direct toppling at stations 1, 2, 4, 5 & 7 about intersection planes [(So&J1, J1&J2), (So&J1), (So&J2) and (So&J1)] respectively, as shown in Figures 5d, 6, 7d, 8, 11d, 12, 13d, 14, 17d & 18.

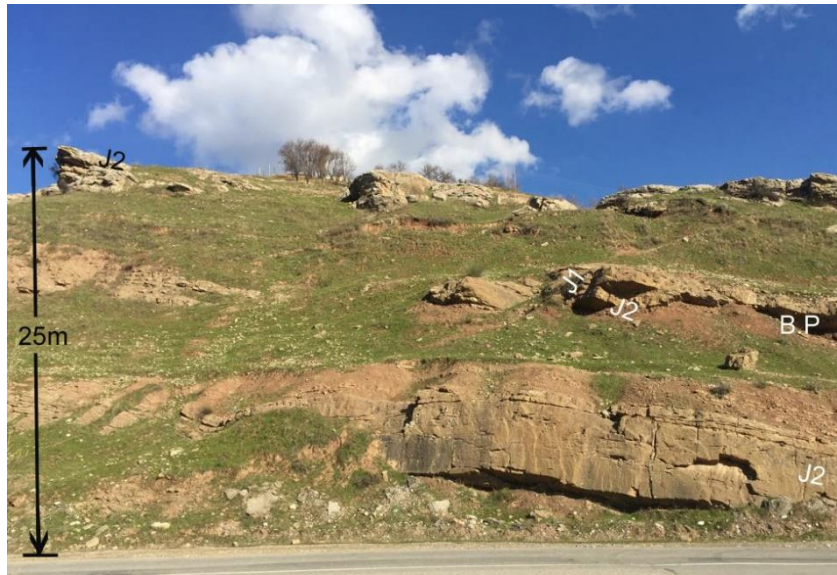
Fig. 8: General view for slope at station no.2 with marked discontinuity sets

shown in Figures 7b, 8, 9b, 10, 11b, 12, 13b, 14, 15b, 16, 19b, 20, 23b & 24.

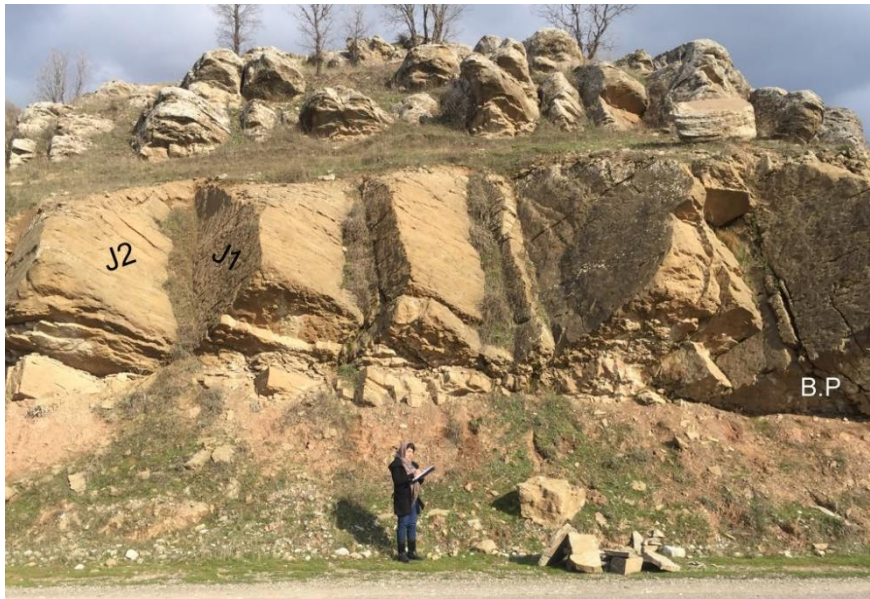
Fig. 10: General view for slope at station no.3 with marked discontinuity sets

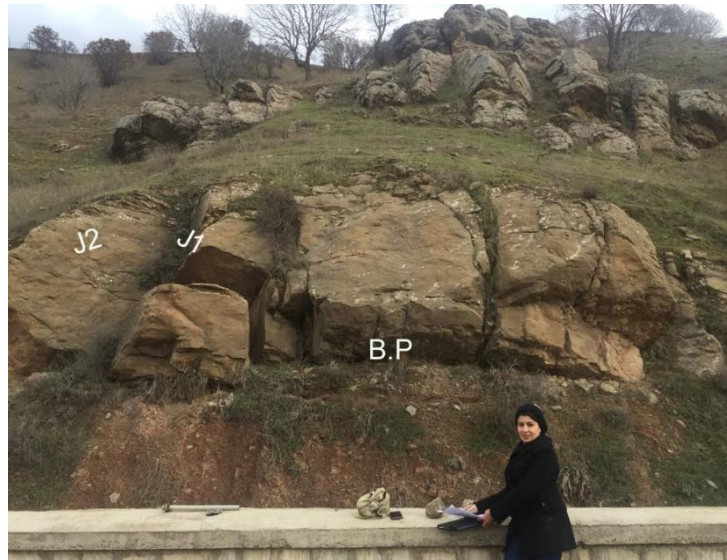
Fig. 12: General view for slope at station no.4 with marked discontinuity sets

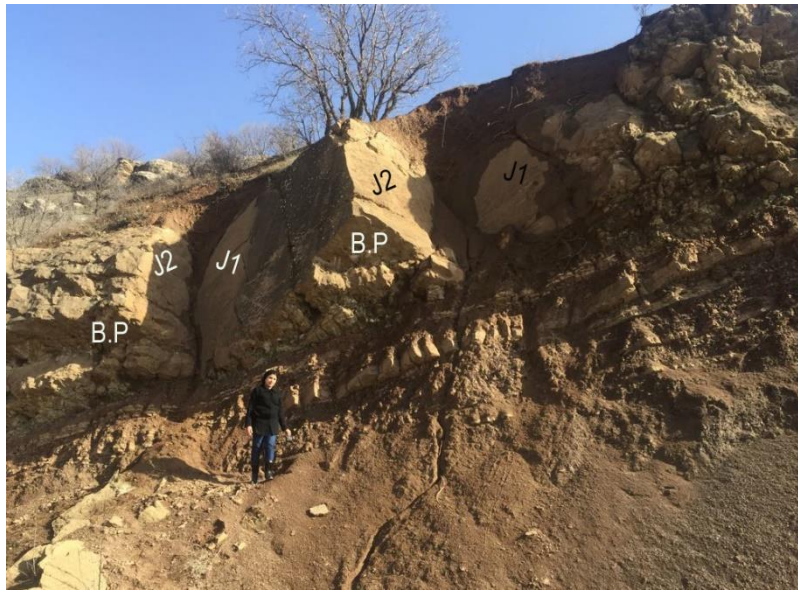
Fig. 16: General view for slope at station no.6 with marked discontinuity sets

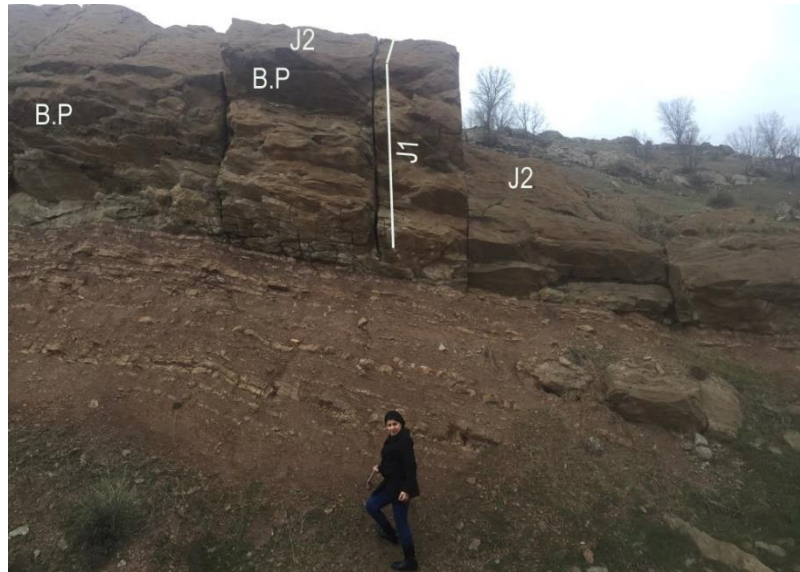
Fig. 18: General view for slope at station no.7 with marked discontinuity sets

1) Potential for planar sliding at stations 5, 7 & 9 on J3, J2 & So (bedding plane) respectively, as shown in Figures 13a, 14, 17a, 18, 21a & 22.

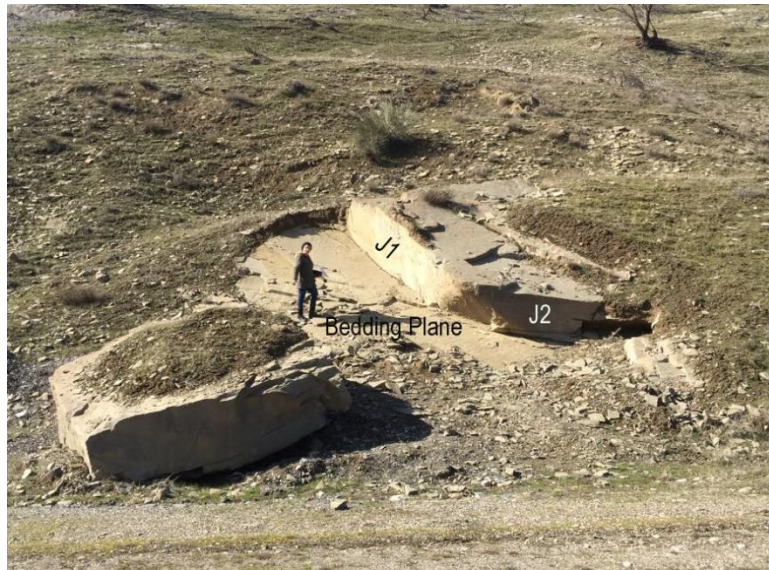
Fig. 22: General view for slope at station no.9 with marked discontinuity sets
