## Studying of rock slope stability for southeastern plunge of Bekhair anticline, North Iraq

Mohammed Rashid Aboud , Ali Ismail Hassan

Department of Applied Geology, College of Science, Tikrit University, Tikrit , Iraq

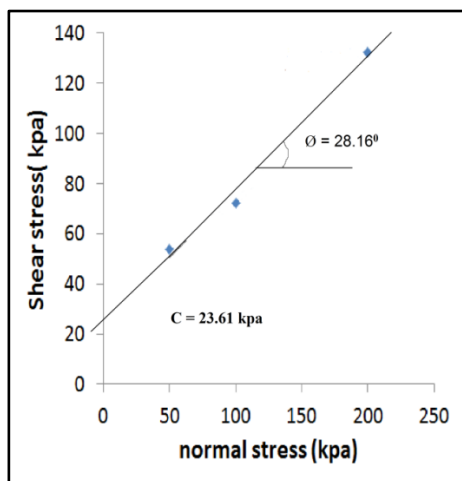
Fig. 2: represents the relationship between the normal stress and Shear stress of the values obtained from the shear test of the station sample (2).

**Direct Shear Test:** This test Considered from Important engineering tests for soil, including measurement of Shear Strength of silt, to find the cohesion (C) and angle of internal friction ( $\phi$ ), this test was done according to ASTM [12]. Since the sample test were disturbed sample, the samples were prepared after taking a certain weight from the (Marl) and adding the water by (8-10%) of the weight of the sample to facilitate the process of compaction or compression ) In the shear mold. There were three parts for each sample and under different weights (2kgm), (4kgm) and (8kgm), respectively. and the shear stress was recorded after the failure of each sample and The results were then obtained. The relationship between the three normal stresses ( $\sigma$ ) and the shear stresses ( $\tau$ ) of the sample was plotted, where the relationship was represented in a straight line and the slope of the line with the vertical stress axis ( $\sigma$ ) is the value of the angle of the internal friction ( $\phi$ ) The straight line with the shear stress axis ( $\tau$ ) represents the cohesion value (c), as in Figure (2).

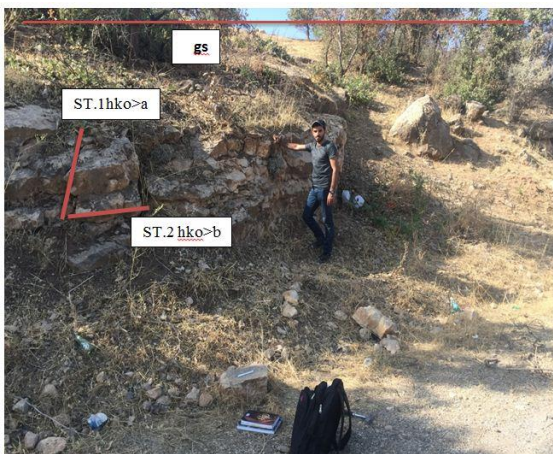
**plate 1: Front view of station No. (1), show the discontinuities in the rock blocks, the direction of the photograph (south-east).**

This station consists of a slope of 3 m in height from toe, and the length of the face towards strike is (12 m), its attitude (324/72°-OH), parallel slope (d = 1o) the attitude of limestone bedding in this station is (° 325/°29), (figure .2).

Which have the following characteristics light color gray, thick bedded, with moderately strong compressive strength ( $\sigma_c = 32.69$  MPa) the slightly weathering SW.

The limestone layer is contain two set of joints (Fig. 2), the first set (ST.1) pe (hko> a) the spacing between the joints ranges from 35-40 cm and thus has moderately wide spaced, their persistence (50 cm) on bedding plane, open in some parts for a distance (2 cm), filled with the quatrny deposit that covering the slope and its attitude (°212/°79).

The second set (ST.2) (hko> b) the spacing between the joints ranges from (15-25 cm) and thus has moderately wide spaced its persistence up to (20 cm) on the bedding plane, closed, and its attitude (°126/65 °).

The slope is formed the result of the road cut, the type of failure is rock fall due to the presence of hanging parts of the slope and the cohesion through the discontinuity equal(zero).

and failure of the same type is likely to occur when the cohesion become zero, where conditions are available for rockfall except for cohesion through discontinuities.

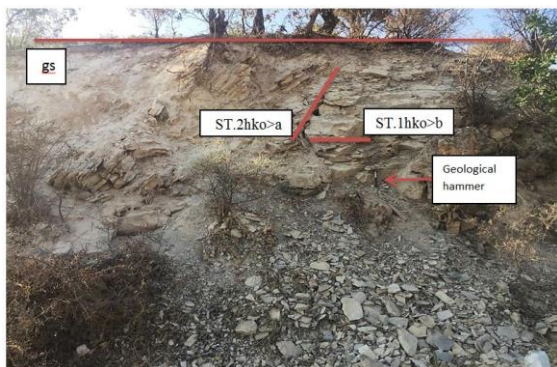
plate 2: Front view of station No. (2) Direction of photography (South – East)

This station consists of a slope of 7.32m in height from toe, and the length of the face towards strike (23 m), its attitude (341/61°-OH), parallel slope there are (d = 4°) and attitude of bedding in this station is (° 345/°31), figure (3).

expose A very thick layer of limestone in upper part of slope up to (4 m) very fine grains, light yellow color, slightly weathering SW, compressive strength ( $\sigma_c = 30.08$  MPa) Moderately strong and the lower part of the slope consists of thickly bedded of marl (1.5 m) light gray color, moderately strong compressive strength, fine grains, and high weathering (HW).

The slope is form result of cutting operations become of instability in the face of the slope. The probability of Failure is of plane sliding when the cohesion across the discontinuities (zero) and the slope angle is higher than the dip of the layer. The stability of this type of slope depends on the angle of internal friction ( $\phi$ ) and the value of the cohesion (C) of marl, The results showed that the internal friction angle ( $\phi$ ) (°28.16) and the cohesion value C = 23.611 Kpa since the internal friction angle is less than the angle of the layers, the probable Failure is of plane sliding type.

The discontinuities (ST.1hko> b) play the role of back release surfaces, and the discontinuities (ST.2hko> a) are lateral release surfaces.

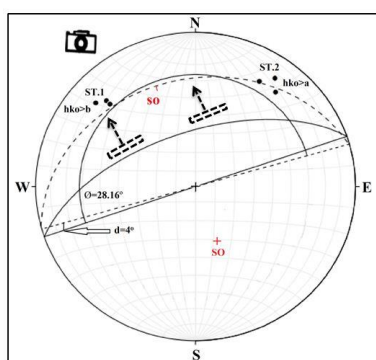
Fig. 3: diagram showing the relationship between the slope and the bedding and discontinuities, as well as the probable failures of station No. (2) direction of photography (south-east)

The limestone layers cutting by two set of joints , In addition to bedding plane fig (3), the first set (ST.1). (hko> b) The spacing between joints ranges from 20-30 cm moderately wide, with persistence ranging from 0.5 to 1 m on the of bedding planes, closed, and attitude (°133/°68).

The second set (ST.2) (hko> a), with spacing ranging between 35-40 cm. Moderately widely spaced and its persistence are up to 2 m on the bedding plane, Aperture 2 cm and filled with sediments above the slope, and their attitude (215/70 °).

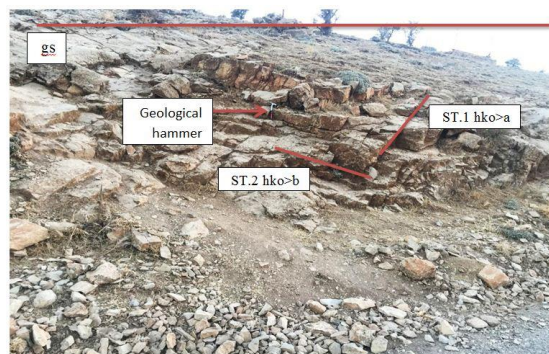
plate 3: Front view of Station No. (3) Direction of Photography South - West.

This station consists of a slope of 8m in height from toe, and the length of the face towards strike (75 m), its attitude (016/23-OH), parallel slope (d = 7°) and attitude of bedding in this station is (°28 / ° 009), figure (4).

There are a very thickly bedded of limestone exposed on face of slope with thickness (7 m) light Brown colored, very fine grains, moderately strong compressive strength ( $\sigma_c = 26.01\text{Mpa}$ ) and slightly weathering SW.

The slope is form result of cutting operations resulting day lighting bedding plane, the type of failures rock fall, due to presence of hanging slope. The possibility of other failures of the same type when the slope face exposed to the processes of weathering and erosion in the lower parts of the slope, which leads to the removal support of limestone in the face of the slope and when the cohesion through the discontinuities (zero), this will lead to the failures of the type of rockfall in the direction of the street.
